**RE: Geotechnical Report Summary for Hillside Stabilization at Streamside**

Trinity | ERD was retained by Associa Hawaii, on behalf of its client, Launani Valley Community Association (LVCA), to provide inspection, observation, analysis and design/construction services for the hillside stabilization at the Streamside Condominiums. The LVCA is a master association comprised of six individual condominium developments: Ridge, Gardens, Terraces, Woodcreek Crossing, Woodcreek and Streamside. The Streamside development is located furthest into the Launani Valley and adjacent to Waikakalaua Stream.

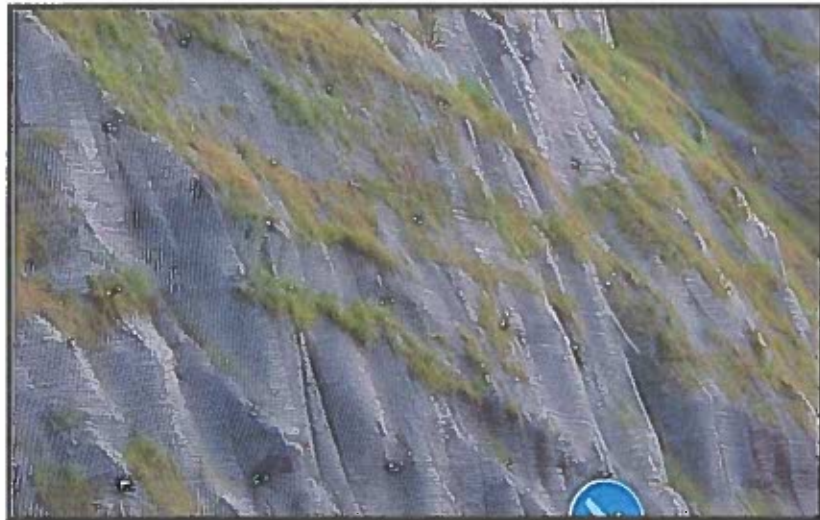
- I. The Geobrigg TECCO System combined with Geobrigg TECMAT utilizes a multi-system approach to aid in the erosion control of hillsides. Initially, the TECMAT is draped over the slope to protect from erosion and will aid in the re-vegetation of the hillside. Then the TECCO G45/2 high tensile steel wire is draped over the TECMAT. The entire system is held in place with the soil nails installed per the project specifications developed by JPB Engineering. The rough cost estimate to install the Geobrigg TECCO System is \$3,900,000. The Geobrigg TECCO system does not provide any warranties or specific life cycle time lines; however, it is reasonable to expect a 30 year service life as long as the slope remains stable.

Photograph 1 – Example of Geobrugg TECCO slope stabilization system in place

Although the TECCO Mesh method is more expensive in comparison with the Concrete Face method, re-vegetating the hillside in conjunction with the high-tension steel mesh would be the most effective method to stabilize the hillsides long term. The board would need to budget in landscaping of the vegetation on the hillside, but the regularly scheduled landscaping maintenance can also be used as a method of regular inspection of the stabilization system. The aesthetic appearance of the TECCO Mesh may also be more appealing to the unit owners in the long term.

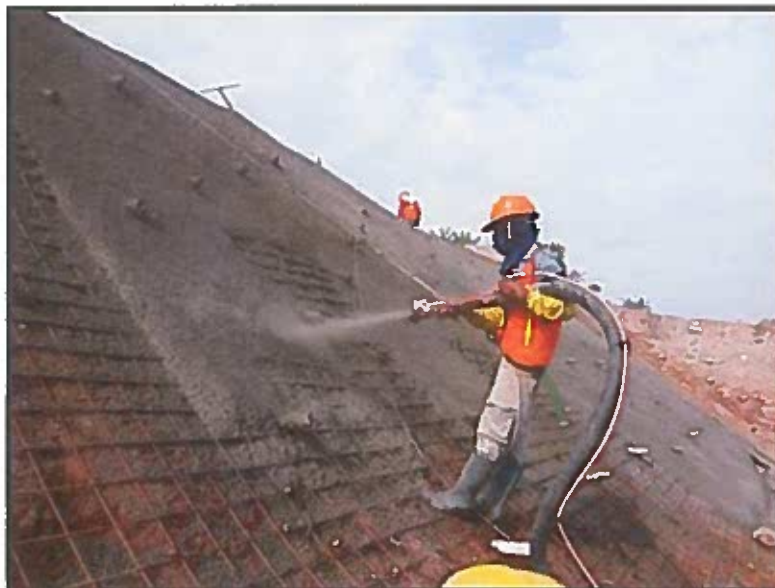
2. The “Concrete Face” method uses a reinforced gunite or shotcrete concrete system. A #10 galvanized steel mesh is installed against the hillside that is to be stabilized to minimize soil erosion from occurring behind the concrete face. Then a drainage system will be installed in horizontal lines along the midpoints of the soil nails to alleviate water from building up behind the concrete face. The concrete face will have a minimum compressive strength of 3,000 psi and reinforced with a 6”x6” welded galvanized steel mesh. The rough cost estimate to install the concrete face method is \$2,200,000. The concrete face method does not provide any warranties or specific life cycle time lines; however, it is reasonable to expect a 30 year service life as long as the slope remains stable.

Photograph 2 – Example of Concrete Face Hillside Stabilization
